This paper discusses how to successfully profile a printed circuit board when reworking Ball Grid Array and Chip Scale Packages.

Board Profiling for Production vs. Rework

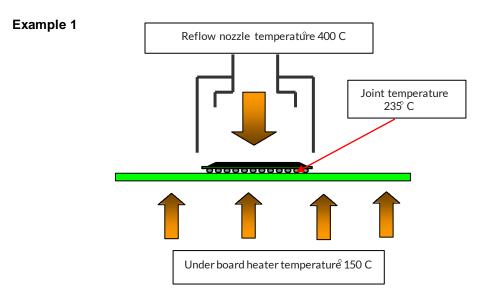
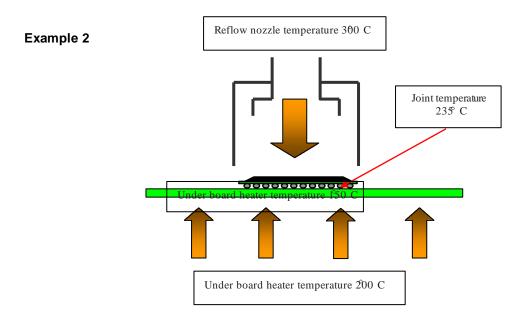
On any reflow soldering system that heats both sides of the PCB assembly, the required solder joint temperature is a function of how much heat is applied to both the top and bottom side. It is quite possible to achieve the same solder joint temperature with a number of heat settings. The following 2 examples illustrate this.

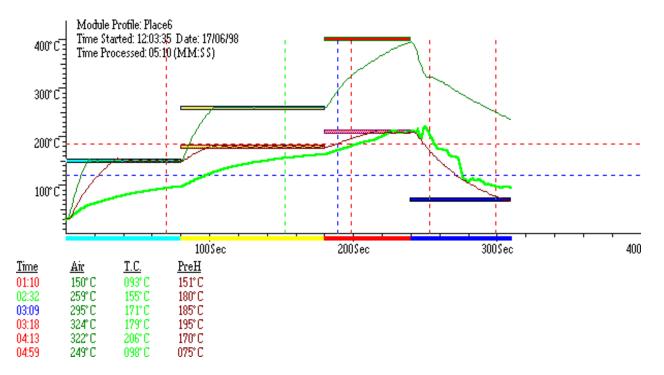
The graph below shows a trace of a profile taken from under a 492 PBGA on a PC motherboard where the thermocouple trace appears to be normal – hitting the desired pre-heat, soak and reflow temperatures. In this case with either solder paste or flux, a very low pass rate was achieved.

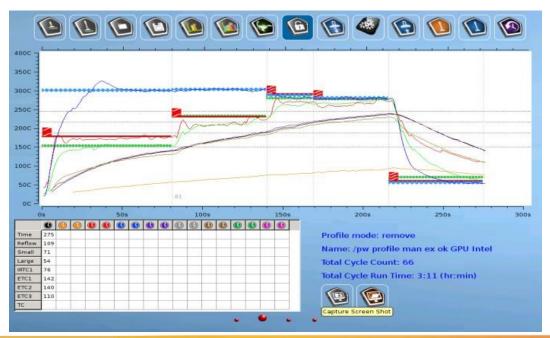
The second graph shown is the final profile that was used, and as you can see, the 2 traces are very similar but the heating has been done in a totally different way. In this case, we have increased the number of zones to 4, reduced the top air temperature significantly while increasing the underboard heat to the whole board and utilizing an underboard centralized heating zone.

The route of the yield problems was due to the plastic BGA warping during reflow. An excessive source temperature on the topside of the PCB caused this.

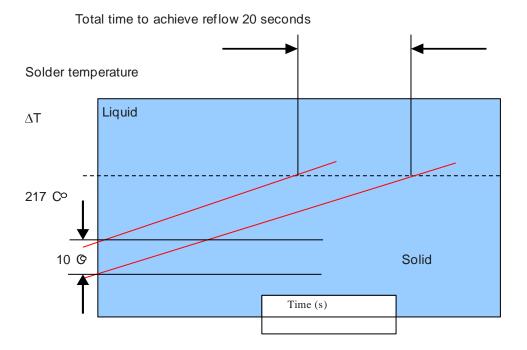
Graph of ramp rate at 0.5 °C/Sec

The following diagram shows a graph section of a components' solder joints going from solid to liquid at a melting temperature of 217 °C. We are assuming that the achieved ΔT across the component is 10 °C.

The rate of temperature rise (ramp rate) will determine the duration of reflow from start to finish. This is directly proportional to the input temperatures set on the profile. In this case the ramp rate is 0.5 C per second.
